**The Role of Protective Visors  
in Injury Prevention During  
U.S. Army Rotary-Wing  
Aviation Accidents**

**January 1998**

**U.S. Army Aeromedical Research Laboratory  
Fort Rucker, Alabama 36362-0577**

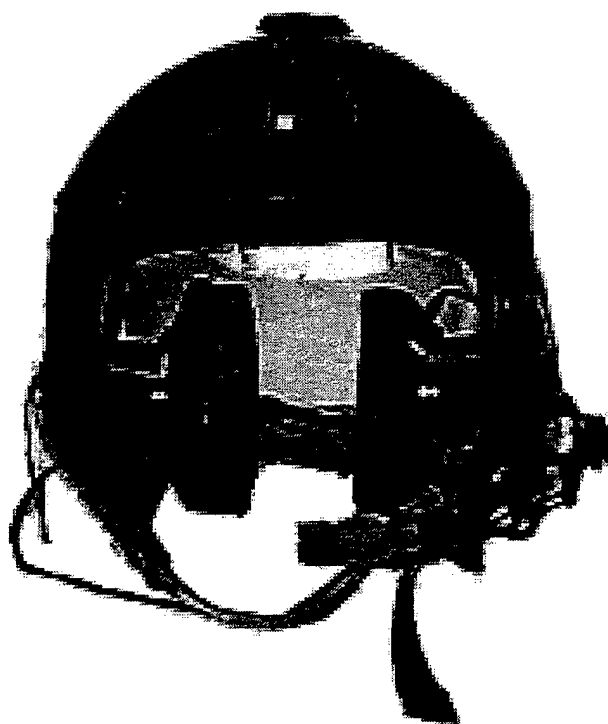
Figure 2. Aviator's Protective Helmet No. 5 (APH-5).

The APH-5 was based on a previous U.S. Navy design. It was molded from glass fabric and polyester resin, providing force distribution and penetration resistance. Helmet fit was achieved by means of pads used to contour the helmet to the head. While maintaining previously

available impact protection, the APH-5 provided minimal hearing protection from aircraft noise (McEntire, 1997). The APH-5 incorporated a single visor.

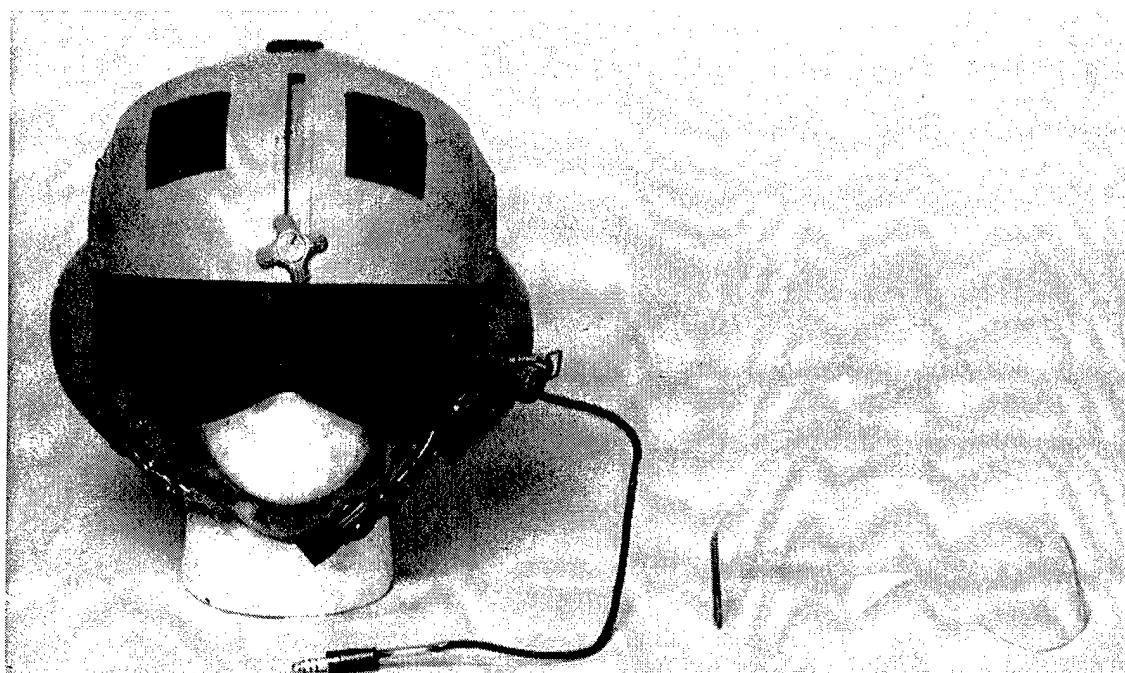
Figure 3. Special Protective Helmet No. 4 (SPH-4).

The SPH-4 was introduced in 1969. At that time, it provided state-of-the-art acoustic and crash protection to aircrew members. The single visor configuration was a tradeoff between weight, impact protection, electronics, etc. A maximum weight, a critical factor in fatigue and crash dynamics, was set at 3.5 pounds. The standard SPH-4 underwent two minor changes: in 1974, a thicker foam liner was used and, in 1982, a thinner shell was adopted. Post-fielding dual-visor adaptor kits were evaluated but rejected due to undue neck muscle fatigue which would be incurred. The recommended visor use at that time was to wear standard issue sunglasses under the clear visor (USAAVS, 1975).

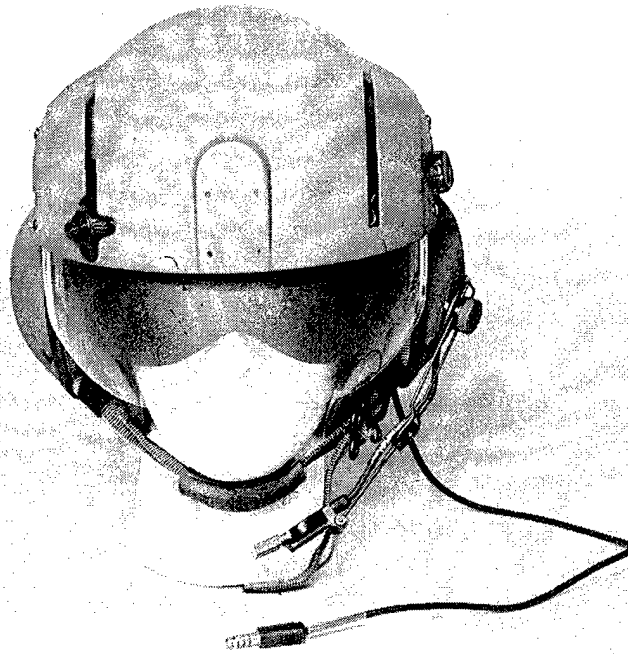
Figure 4. Special Protective Helmet No. 4B (SPH-4B).

The SPH-4B, a vastly improved version of the SPH-4, was fielded initially in July 1991. Its outward appearance is similar to that of the SPH-4. However, its performance is quite different. It has an improved Styrofoam™ liner, new energy absorbing earcups, an improved retention system, a lighter shell of Kevlar™, an Aviator's Night Vision Imaging System (ANVIS) mount, a Thermoplastic Liner™ (TPL)™, and a dual visor assembly (Carter, 1992). The dual visor design allows the use of either or both visors. The SPH-4B is issued with a Class I (clear) and Class II (tinted) polycarbonate visor. The clear visor is mounted on the outside track, with the tinted visor being closer to the face.

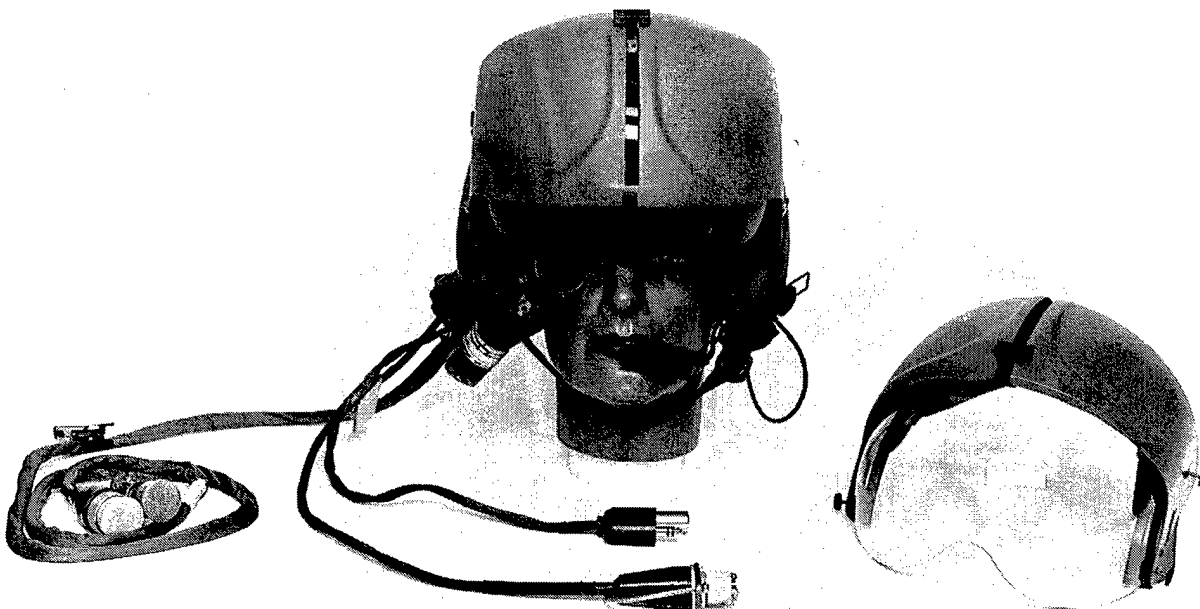
Figure 5. Integrated Helmet and Display Sighting System (IHADSS) Integrated Helmet Unit (IHU).

The IHADSS helmet was developed specifically and exclusively for use in the AH-64 Apache attack helicopter. First fielded in the early 1980's, the IHADSS helmet incorporates a helmet mounted display and head motion sensing capability. The IHADSS helmet provides impact and acoustical protection at least equivalent to that of the SPH-4 (which was, at the time of the IHADSS fielding, the current aviator helmet). Two visors (Classes I and II) are provided in separate visor housings. While only allowing use of a single polycarbonate visor at a time, the two visor housings can be rapidly changed out using simple thumbscrews. [Note: Due to the uniqueness of the IHADSS, the visors must be custom trimmed to enable them to be lowered over the helmet mounted display optics.] The IHADSS helmet was a crashworthiness challenge because now the helmet was being used as a platform for an HMD but still had to provide the visual, acoustical, and impact protection expected from a standard helmet.

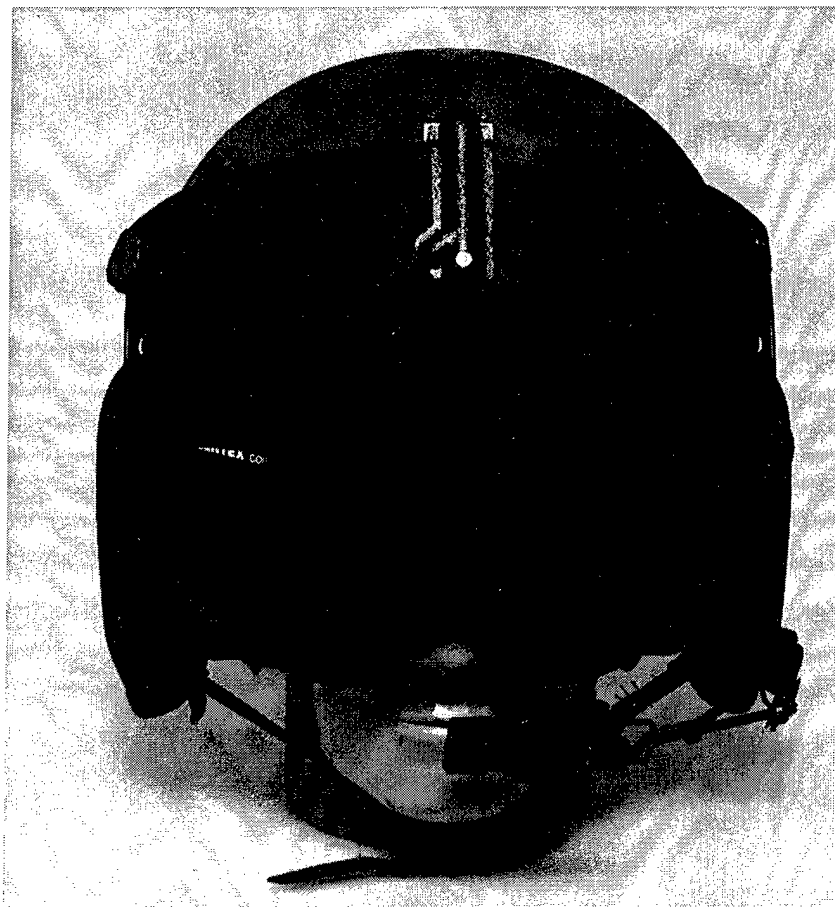
Figure 6. Helmet Gear Unit No. 56/P (HGU-56/P).

The most recently fielded aviator helmet is the HGU-56/P. Besides providing improved impact protection over the SPH-4B, the HGU-56/P moves toward an Army goal of having one common aviation helmet. The final version was fielded in 1995. The HGU-56/P (2.6 pounds) has a reduced weight over the SPH-4B (2.8 pounds). It retained the TPL™ liner and crushable earcups, but the Kevlar™ cloth shell used in the SPH-4B was replaced with a nylon and graphite cloth shell. The HGU-56/P uses polycarbonate visors, clear and tinted, mounted in a dual visor assembly. The clear visor is mounted closest to the face, reversed from the mounting in the SPH-4B. This change was initiated in hopes that future ANVIS designs would allow visor usage without degrading user performance.

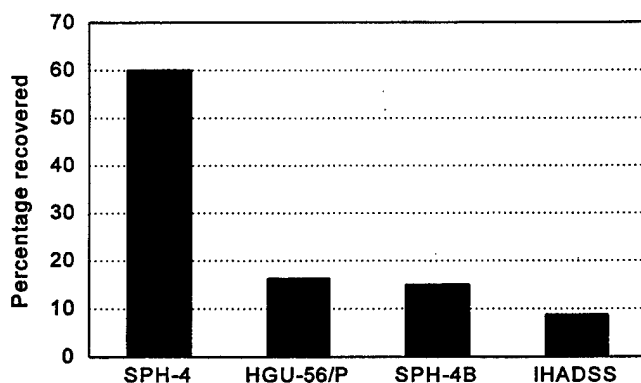
Figure 7. Helmets recovered from ALSERP 1990-1996

Because head injuries remain the predominant cause of severe and fatal injuries to Army aircrew (McEntire, 1997), helmet safety has been a major focus of the ALSERP program. In an inspection of the Army ALSERP data collected during the years 1990-1996, information on 80 mishaps was studied. Included in the data was information concerning the ALSE of 55 aviators and 25 aircrew, all wearing one of the four basic Army aviation helmets: the SPH-4, the SPH-4B, the HGU-56/P and the IHADSS (Figure 7). While information was unable to be collected in some accidents due to postcrash fires and other traumatic events, the statistics do indicate that the majority (70.8 percent) of accident victims did experience some degree of head, neck, or facial injury. Half of all air crash victims were fatalities.

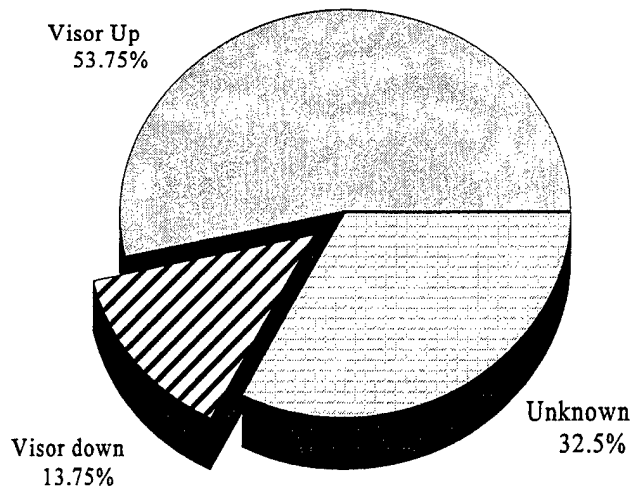
Figure 8. Visor Position for ALSERP  
1990-1996 data.

For all retrieved helmets, visor damage was analyzed to determine the visor position at the time of impact. Of the helmets recovered, a majority of individuals (53.75 percent) were found to have been wearing their visor in the "up" position. [These figures include individuals who were flying with ANVIS. Because the visor cannot be deployed while using ANVIS, the visor is assumed to be in the "up" position.] Only 13.7 percent of the individuals were found to have been wearing their visors down at the time of the mishap (Figure 8). Helmets and visors too badly damaged to ascertain this information were classified as "visor position unknown." For the accidents where visor position was known, it is of interest to note that the frequency of

head/neck and facial injuries experienced by both groups, visor up and down, was identical (70 percent) but varied drastically in severity. Those who wore their visors down frequently were reported to have minor injuries caused by the visor (often due to the visor edge impacting the cheek), but experienced fewer fatalities (18.2 percent for visor down versus 53.5 percent for visor up). This trend is consistent with results reported by Vyrnwy-Jones, Lanoue and Pritts (1988). Their study reported fatality rates of 26 percent among aviators wearing their visor down versus 34 percent for visor up.
